DOUBLE-BELT DRIVE

PS 120-500 M1/M2

MODIFICATION INSTRUCTIONS

Version: 2.0 EN; item number: 00602-3-431

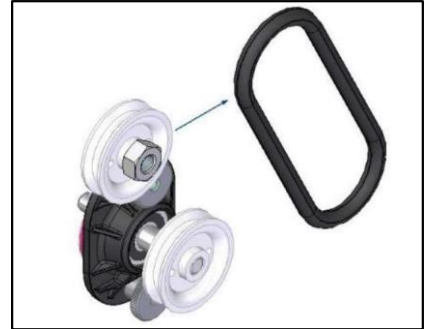
Figure 2: Removing the belt

In the first step, the bearing flange must be removed from the seeding shaft. The procedure here is the same as for changing the seeding shaft. First, the belt cover must be removed by loosening the two nuts. Then the rubber drive belt must be removed (Figure 2), so that the bearing flange can be pulled off the seeding shaft after undoing the two knurled nuts (Figure 3).

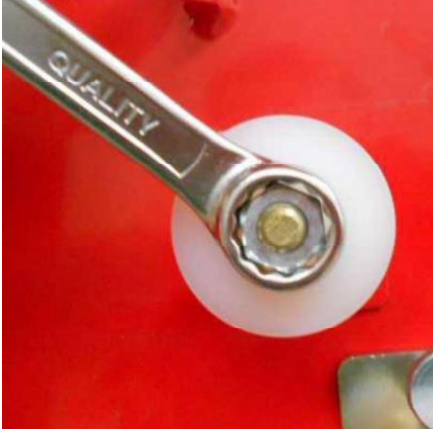
Figure 5: Loosening the nuts

Next, you must loosen the nut on the upper pulley on the agitator shaft, and take off the pulley as well as the nut behind it.

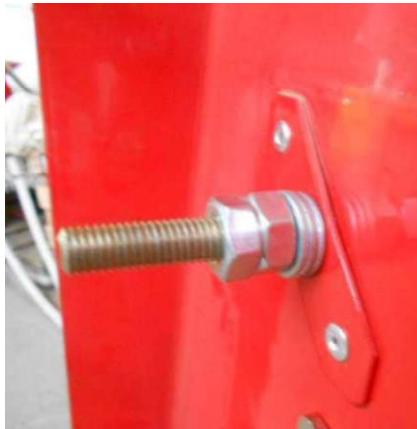
Figure 6: Pulley removed

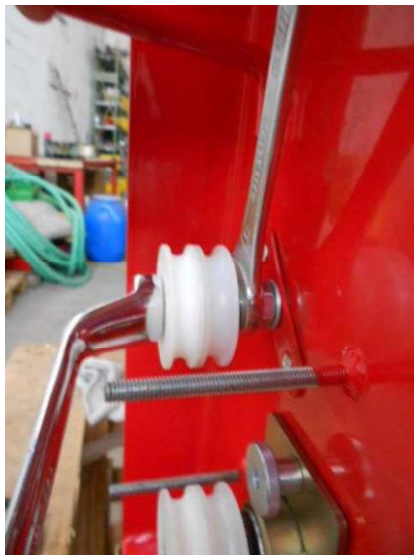
Figure 9: Tightening the nuts

Make sure that the pulleys of the bearing flange and the pulleys of the agitator shaft are aligned, so that the rubber drive belts can run straight. When the pulleys are properly adjusted, fix the position by tightening the two nuts (as shown in Figure 9).
